## Saluda Hydroelectric Project Relicensing

# FERC No. 516

## **SALUDA HYDRO INITIAL CONSULTATION DOCUMENT**

*APRIL 2005*

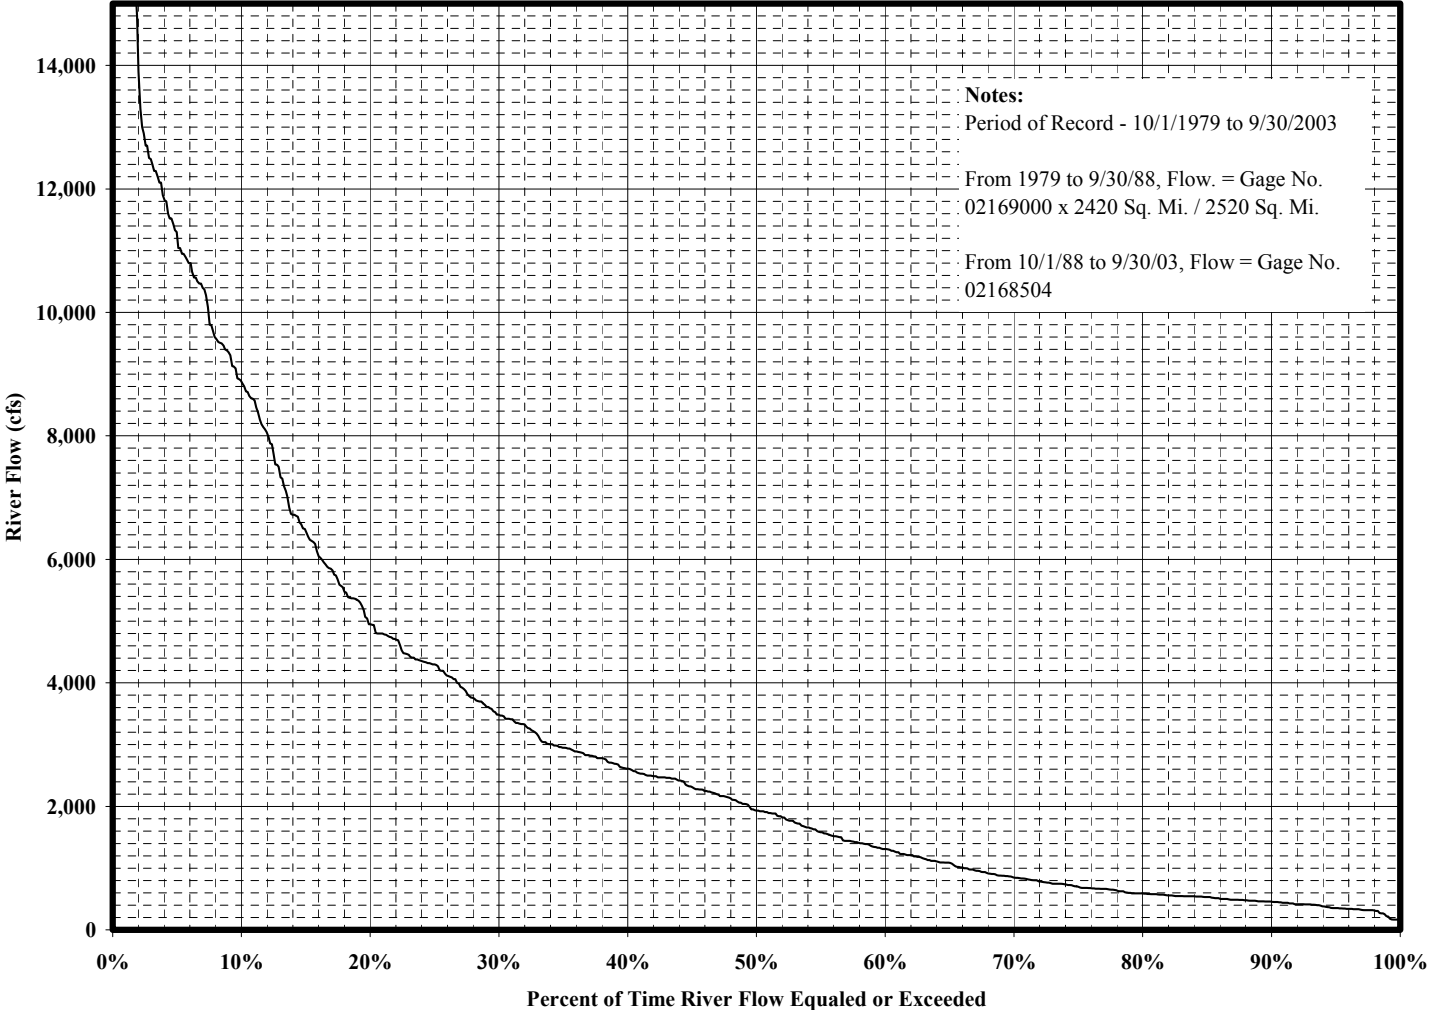
**Figure B-1** Saluda Project FERC No. 516, South Carolina Electric & Gas Co., January Flow Duration Curve

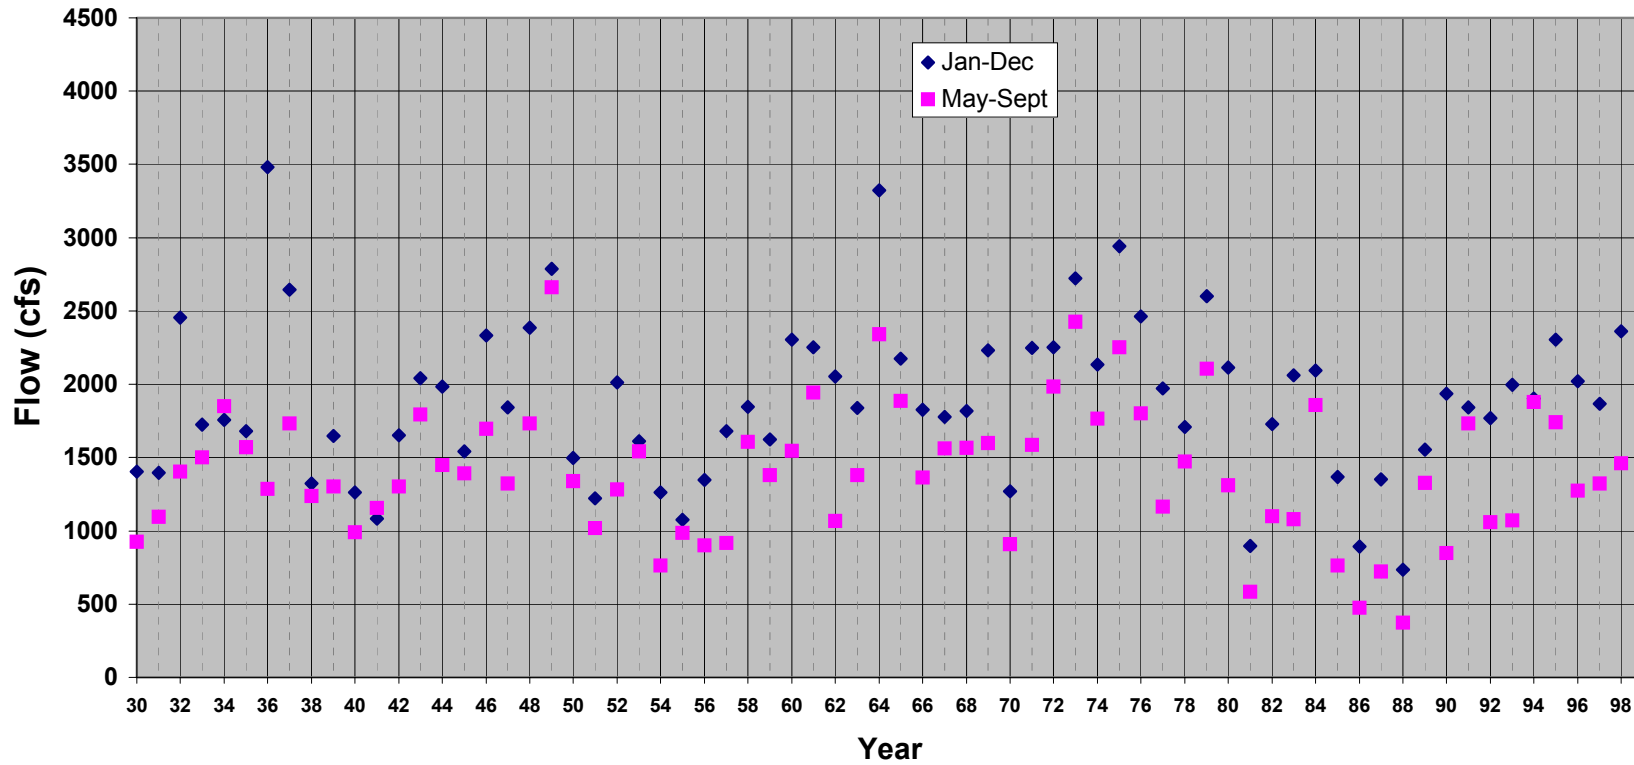
Figure 6: Average Daily Flow at the USGS Gauge at Chappells

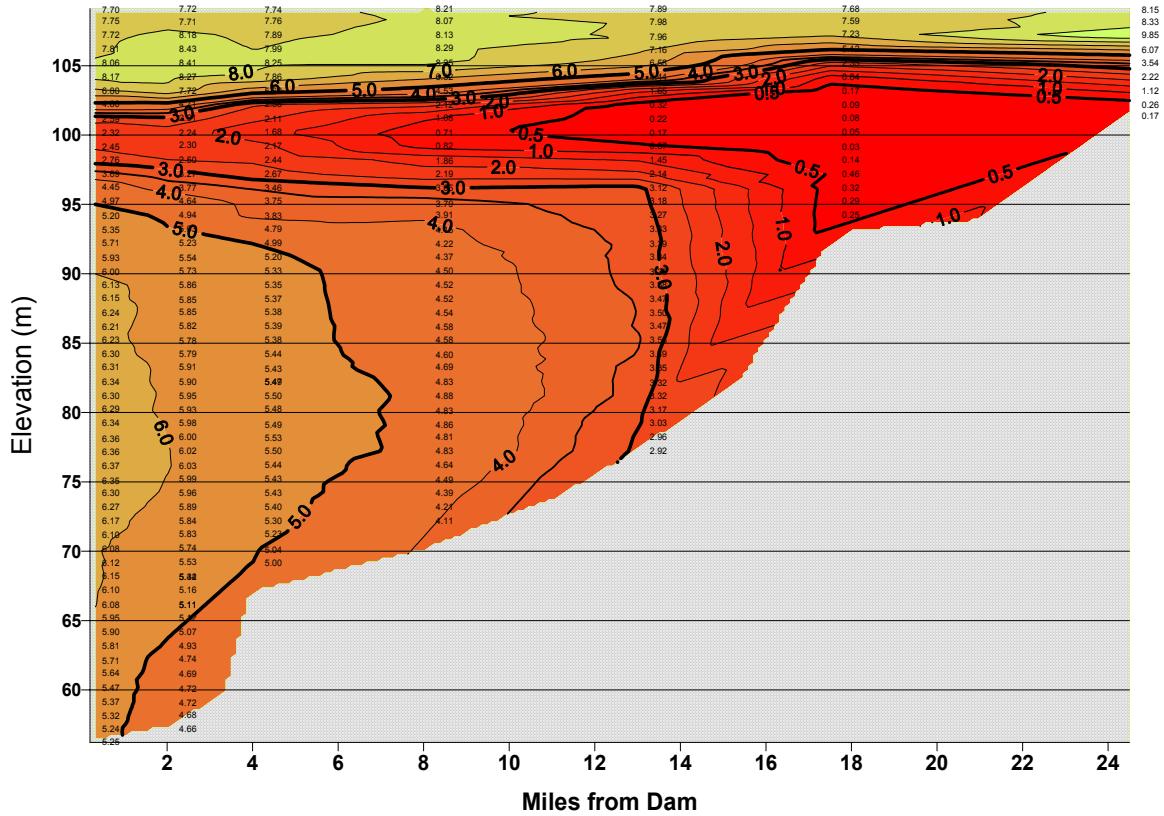
Figure 24: Longitudinal Contour Plot of DO in Lake Murray for 1996

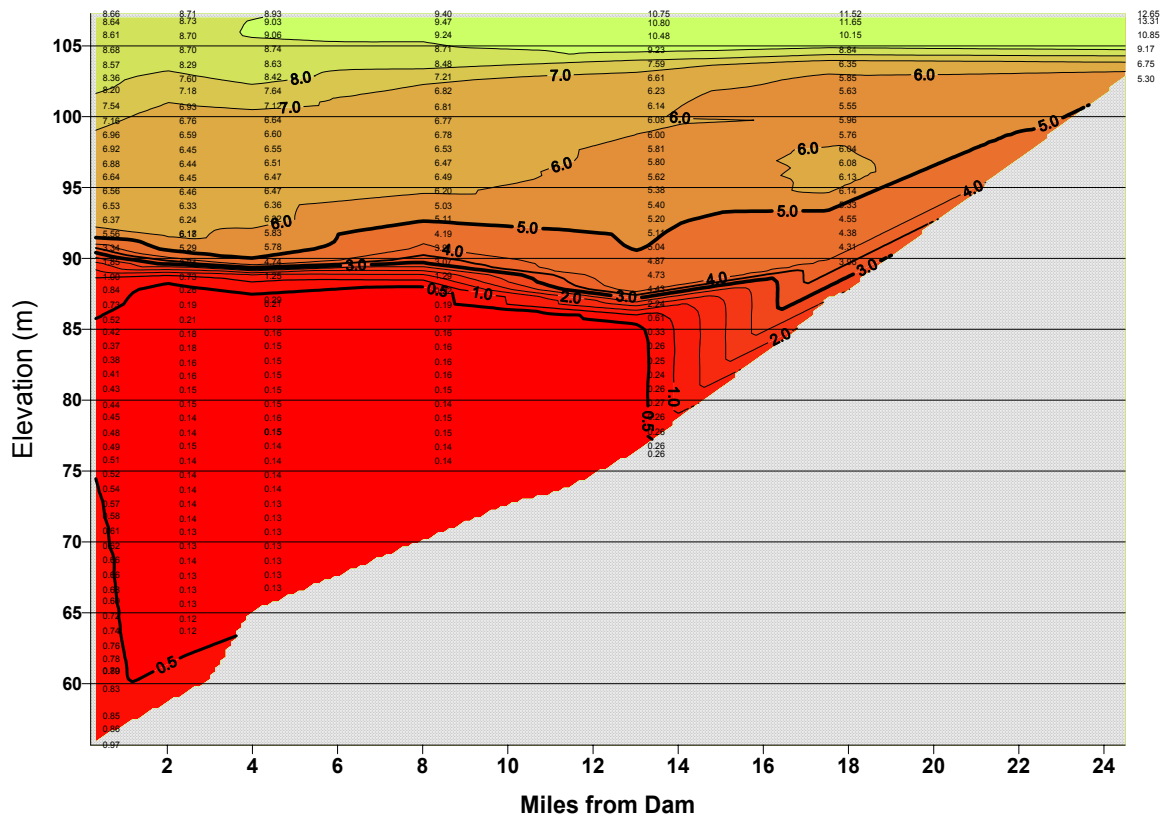
Figure 25: Longitudinal Contour Plot of DO in Lake Murray for 1997 (continued)

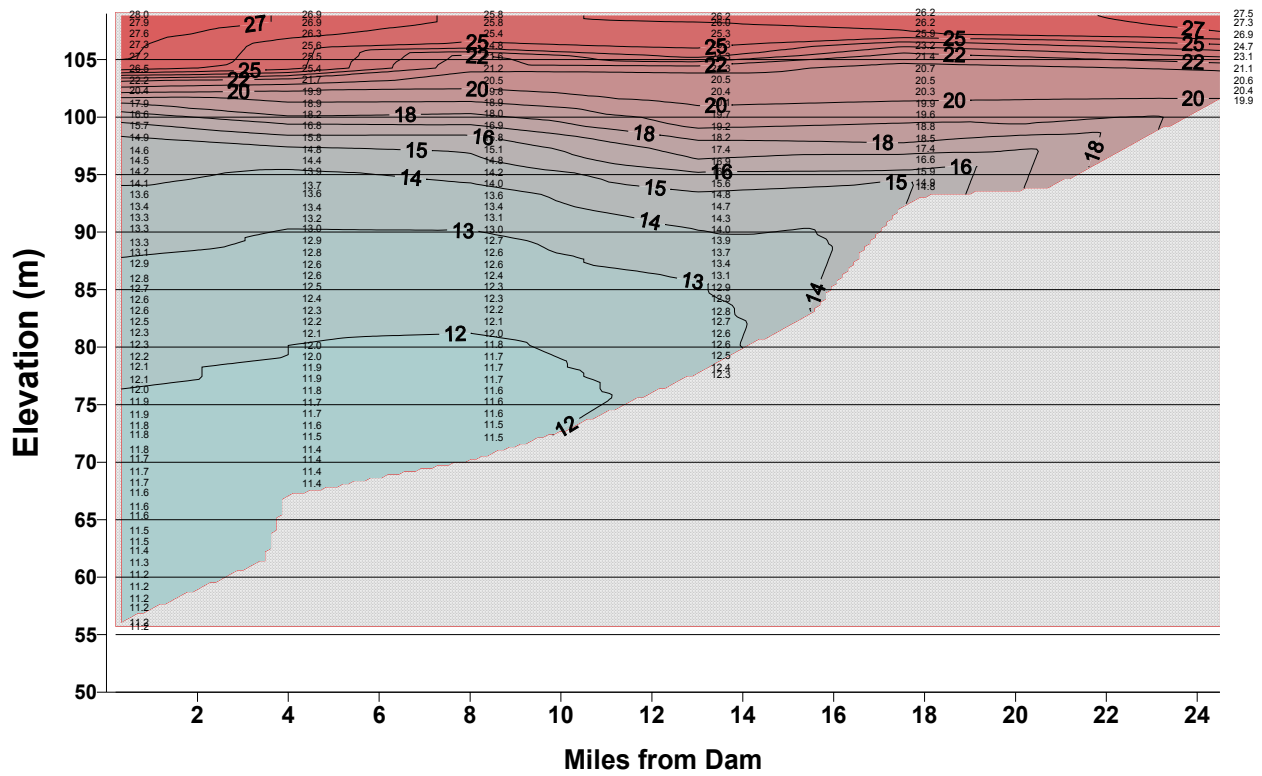
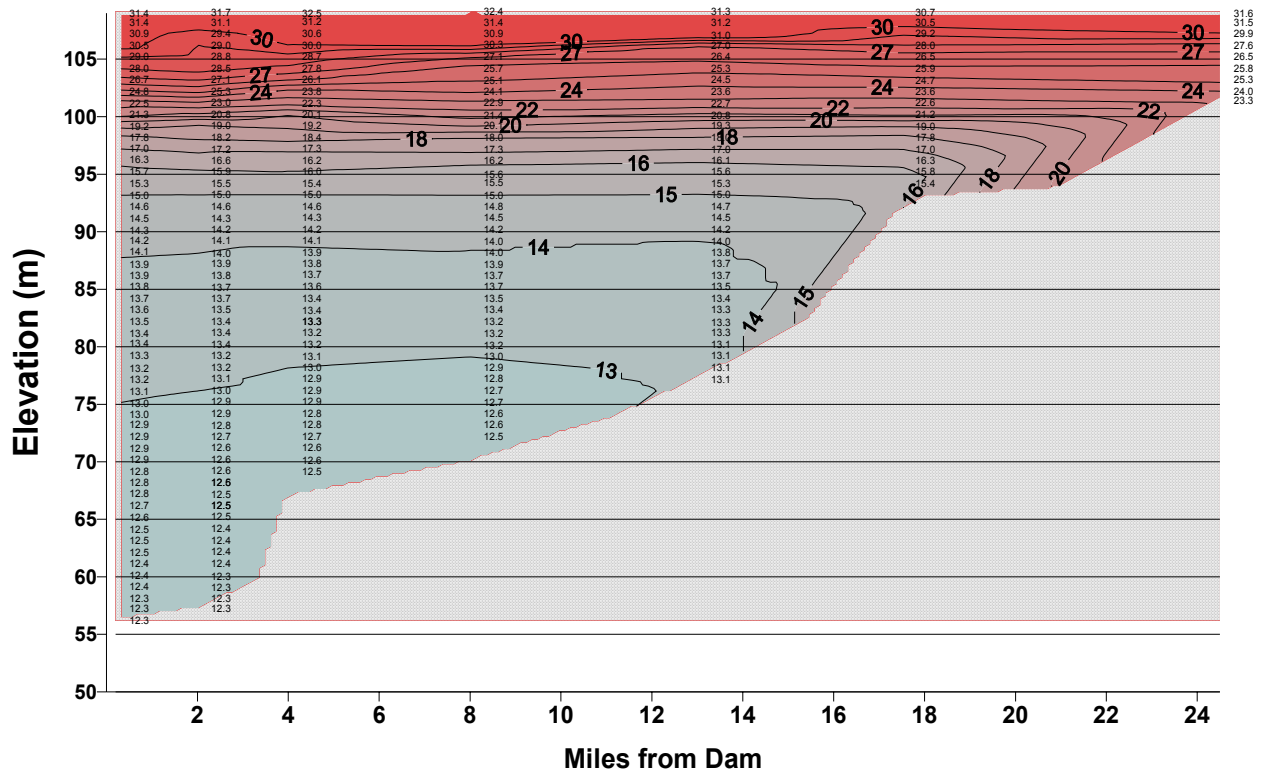
Figure 29: Longitudinal Contour Plots of Temperature for 1996

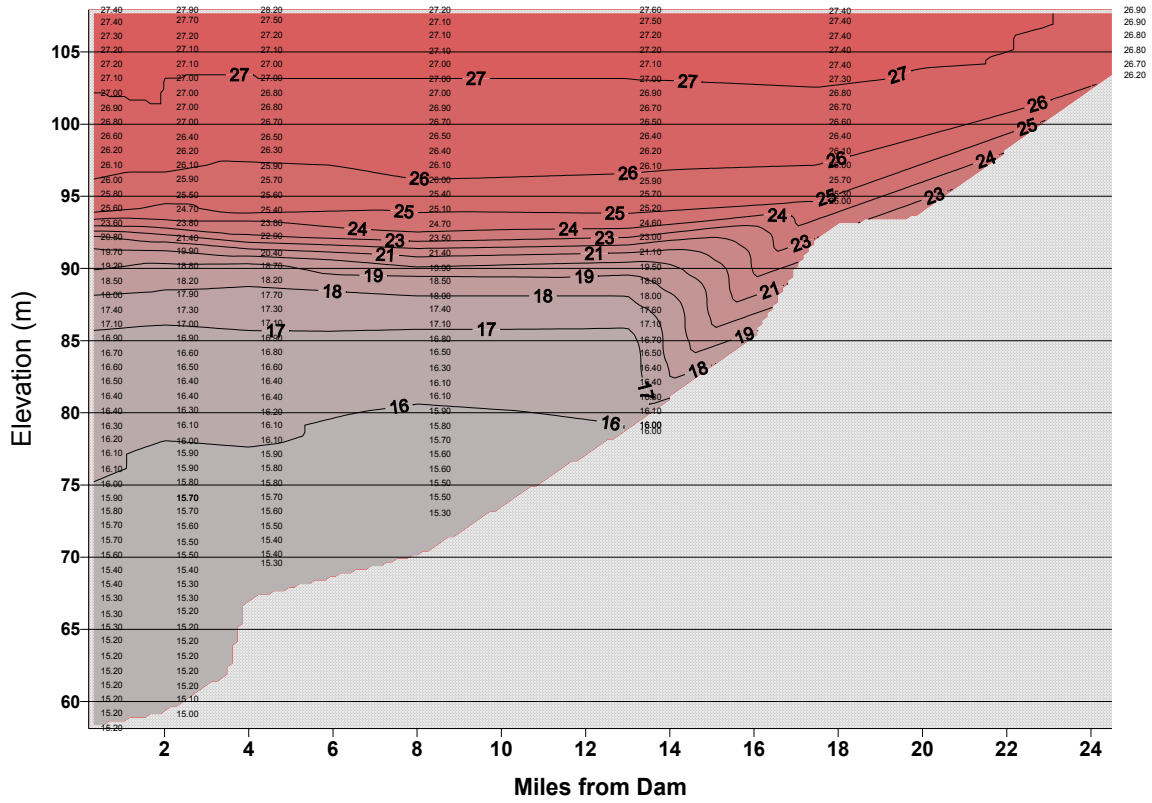
Figure 29: Longitudinal Contour Plots of Temperature for 1996 (continued)

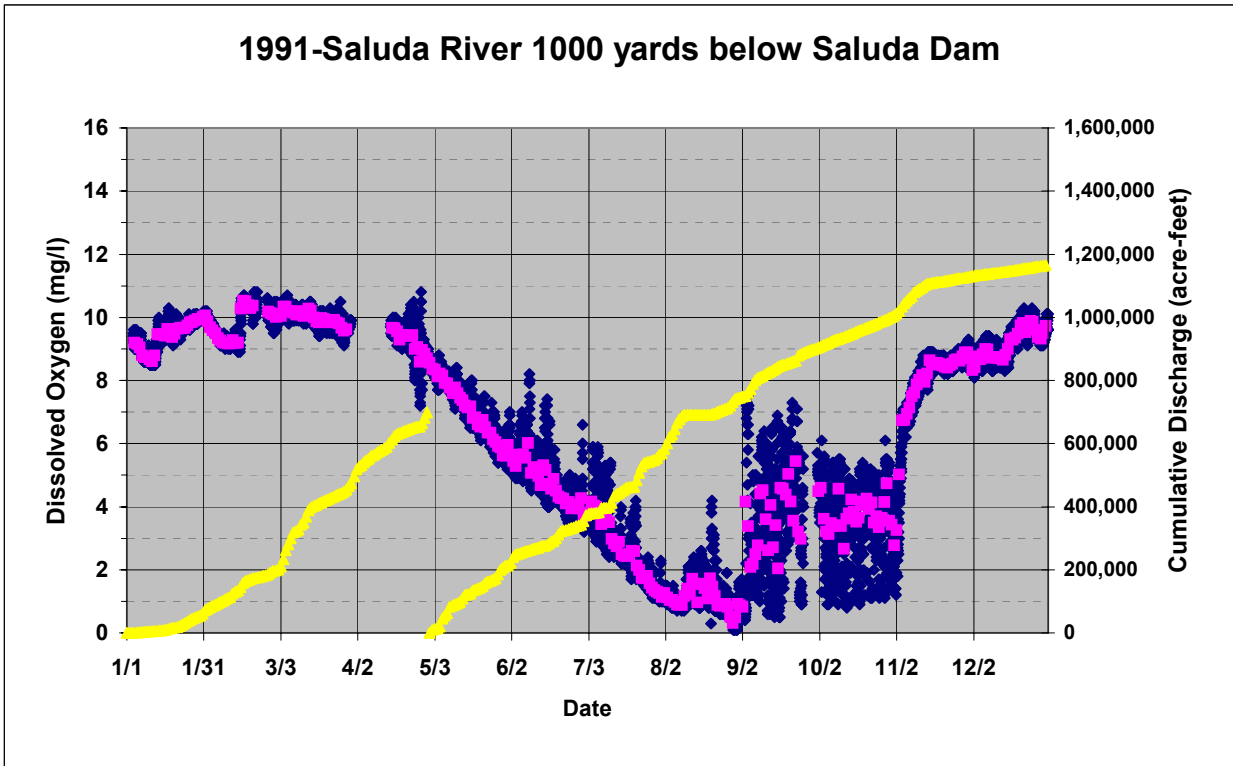
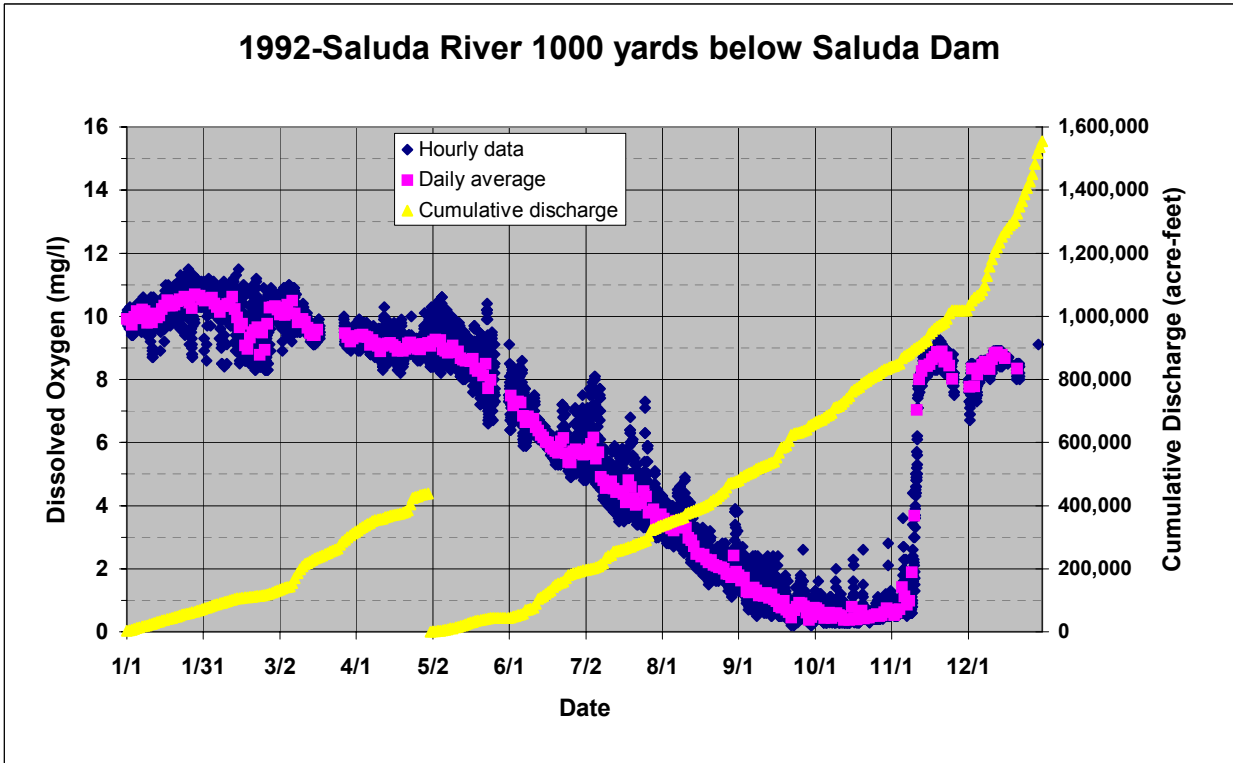
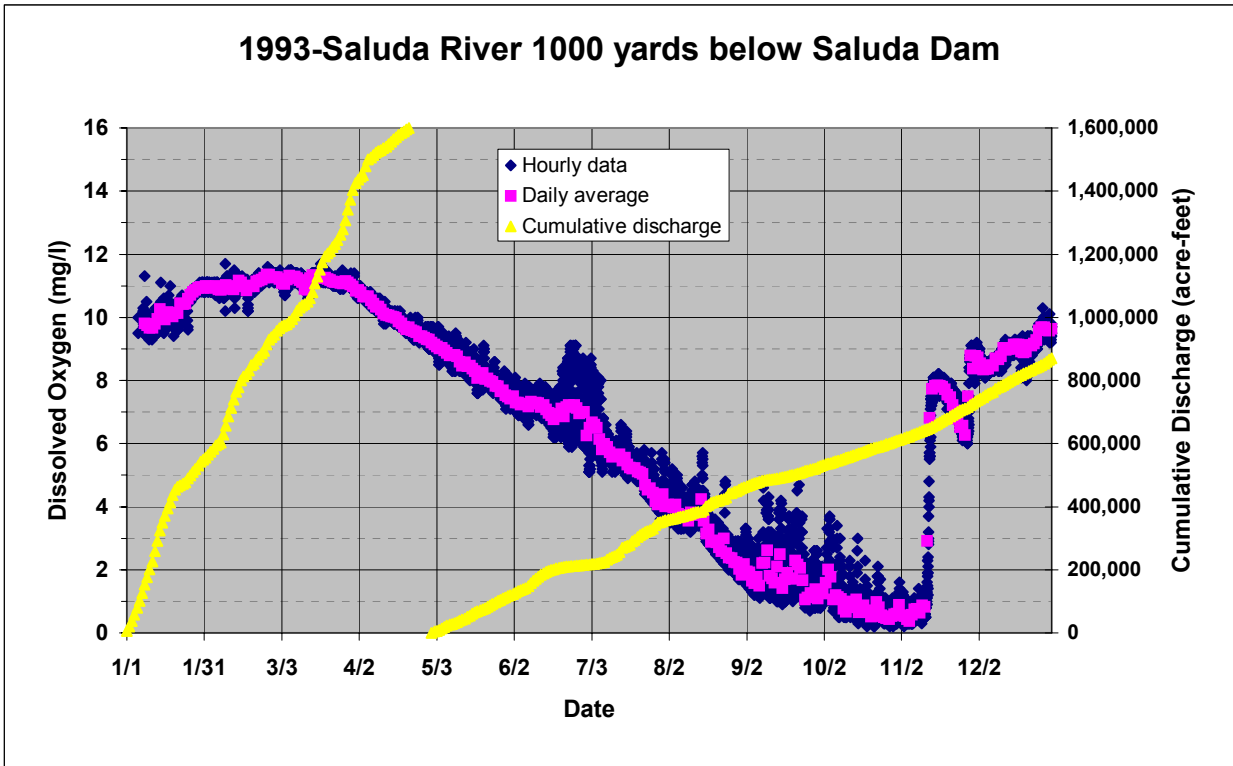
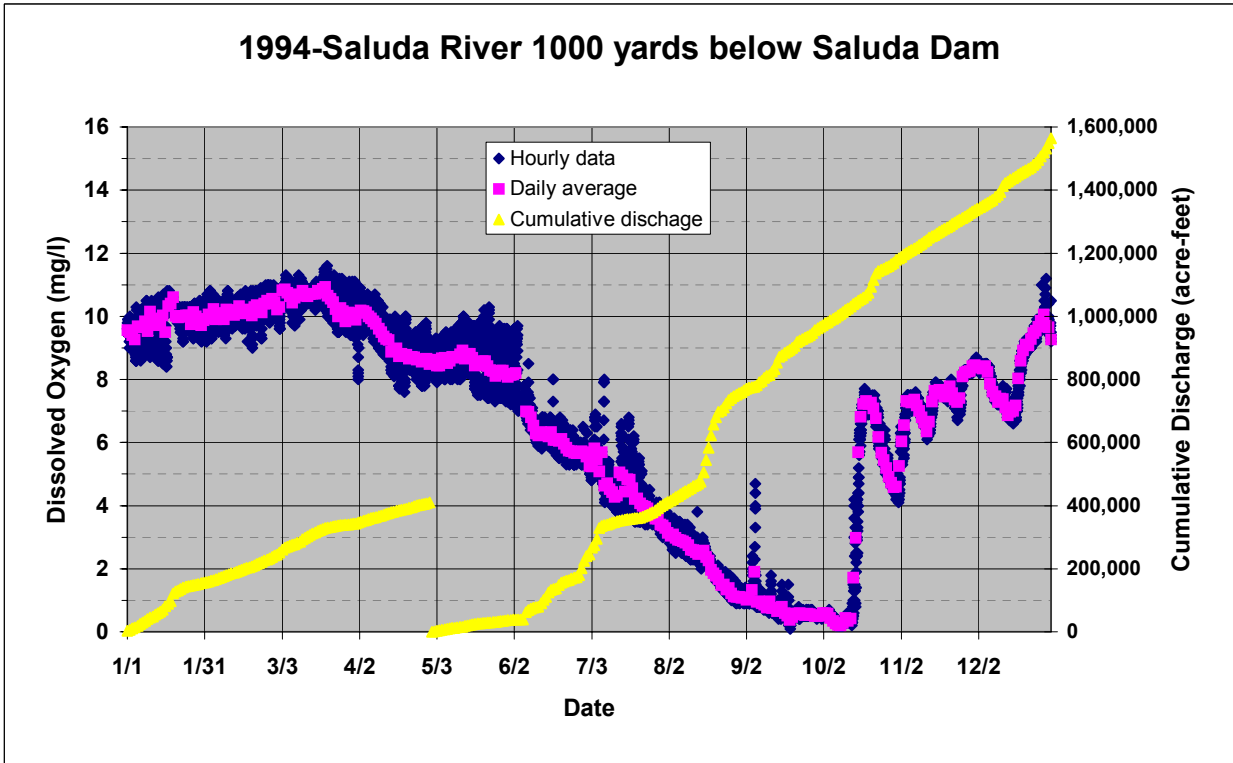
**Figure 32: DO in the Saluda Hydro Turbine Discharges for the Years 1989 Through 2000, Plotted with Cumulative Discharge from January 1 and May 1 (continued)**
